Opera Assessment Report Revision 2

Independent Assessment of Eskom's Operational Situation

August 2023

Client:	National Treasury of South Africa	
Project No:	NT015/2022	
Report Title:	Opera Assessment Report – Revision 1	
Report No:	2 NT_Eskom	
Main Authors:	Bartosz Zajda (Dornier) Manswet Banka (Dornier) Klaus Bransch (Dornier) Vladan Dokic (Dornier) Pieter Janse van Rensburg (Dornier) Dr. Thomas von Schieszl (Dornier) Jörg-Schulte Trux (KWS) Ralf Wiescher (KWS) Rainer Zobel (KWS) Axel Meschbiz (RWE) Petros Terzis (RWE)	Volkmar Bobon (STEAG) Dietmar Breuer (STEAG) Dr. Ruth Egyptien (STEAG) Werner Renk (STEAG) Sener Günes (vgbe) Bernhard Michels (vgbe) Dr. Mark Newby (vgbe) Dr. Claudia Stockheim (vgbe) Dr. Oliver Then (vgbe) Dr. Christian Ullrich (vgbe) Dr. Claudia Weise (vgbe)
Date of Issue:	August 2023

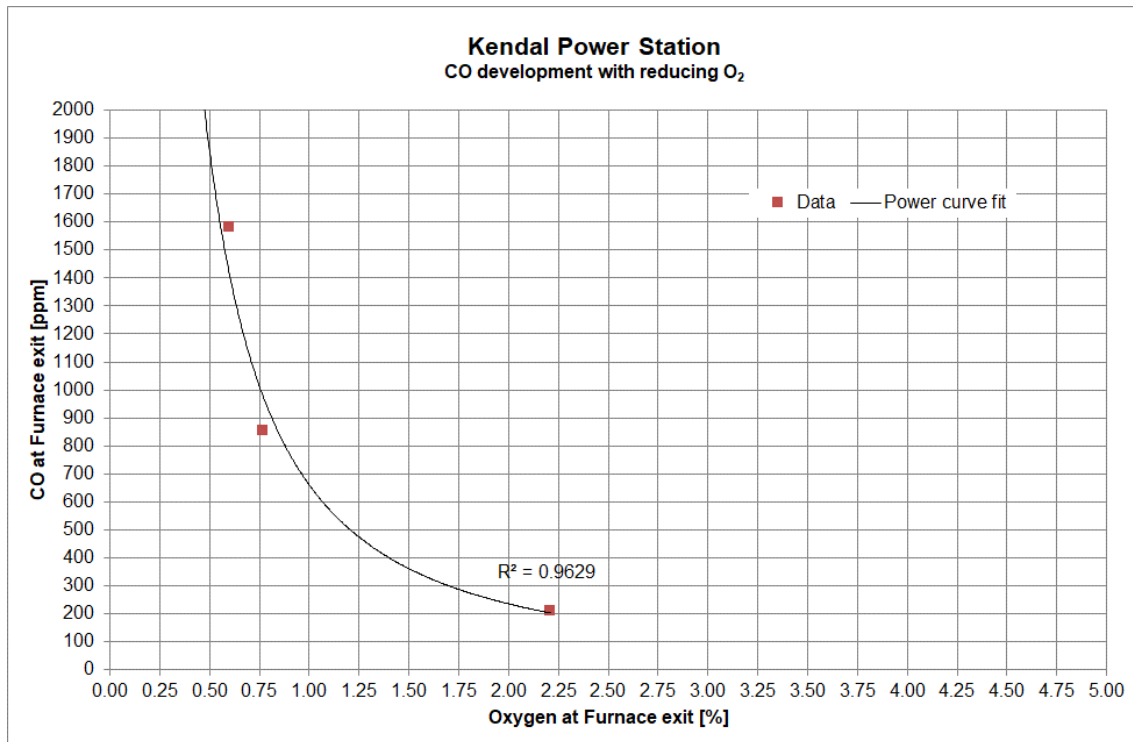
Figure 25: Development of CO as O₂ levels reduce
Source: Eskom

- The generation of CO is not linear and increases exponentially as the O₂ level drops. This is illustrated in Figure 25 using test data from Kendal power station.

- The Lambda parameter is not always reliable as it is a calculated value – dependent on station air and coal measurements.

The vgbe team recommends that any power station wishing to reduce O₂ levels should follow the Eskom directive and motivate the application to the FFFR committee. In addition, the installation of suitable O₂ and CO sensors should be expedited at any power stations that have not already done so.

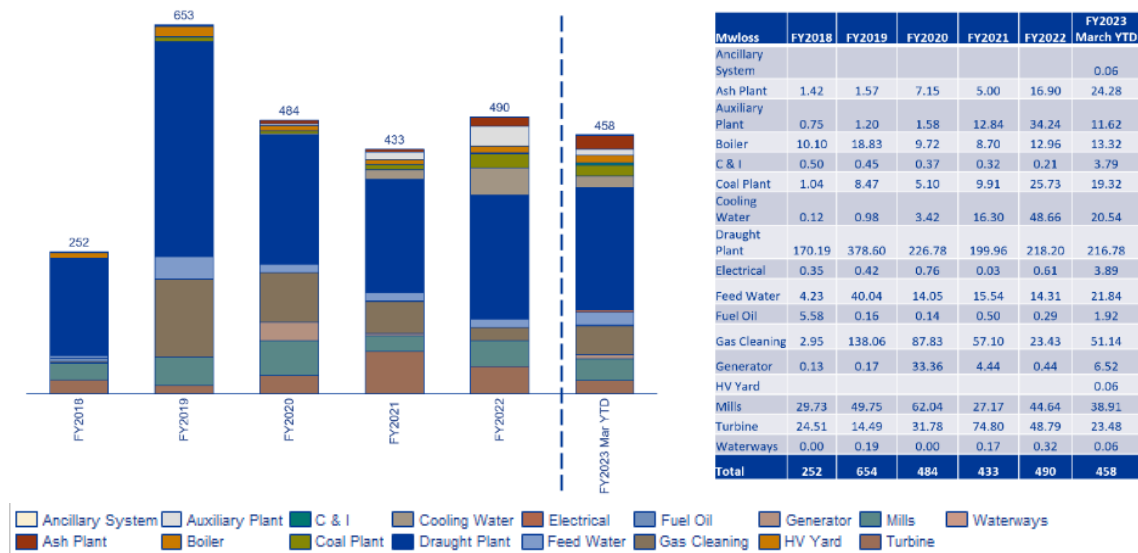
Figure 28: PLL contributors at Arnot power plant (FY2017/2018–FY2022/2023) ¹³

The main PLL sources are shown in the next figure. It shows that many different components influence PLL – the main components are the draught plant, the gas cleaning (fabric filter plant), the mills, the turbine, the cooling water/condenser and the feed water.

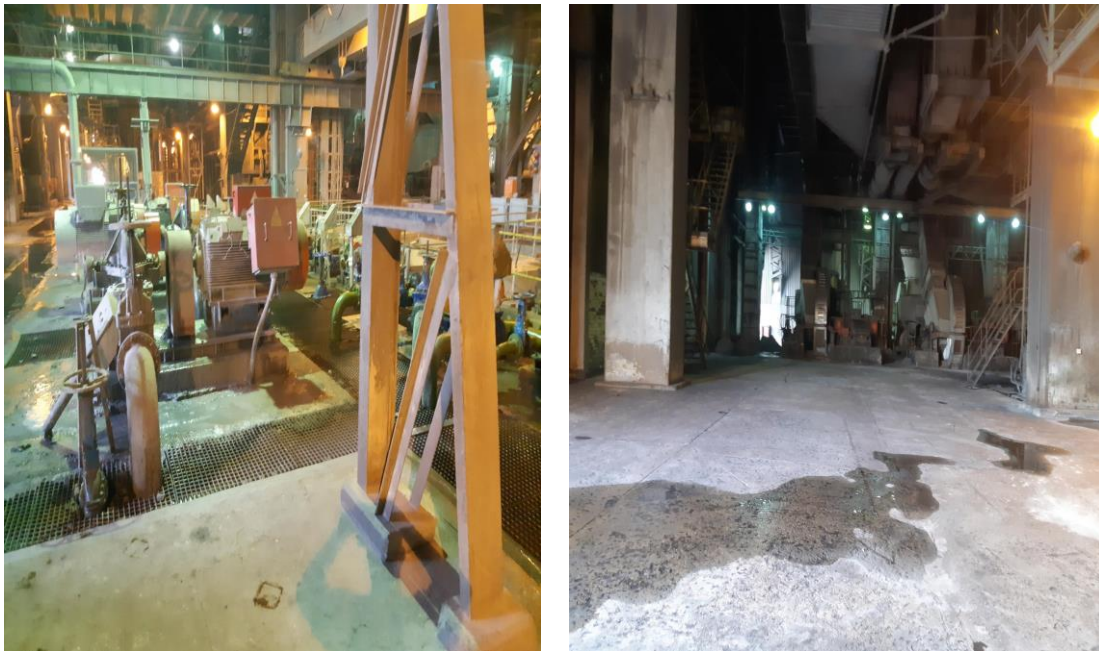
Figure 30: Arnot's boiler house after intense cleaning

The status of the housekeeping is unacceptable. Even if it has no direct impact on plant performance, it is important to keep it at an acceptable level so that it is possible to work safely in the boiler house at all times. During the visit, the plant team promised to immediately take steps to improve the situation. They agreed to send photos after implementing corrective actions. These photos were sent on the 7 May 2023 and showed a significant improvement in the situation.

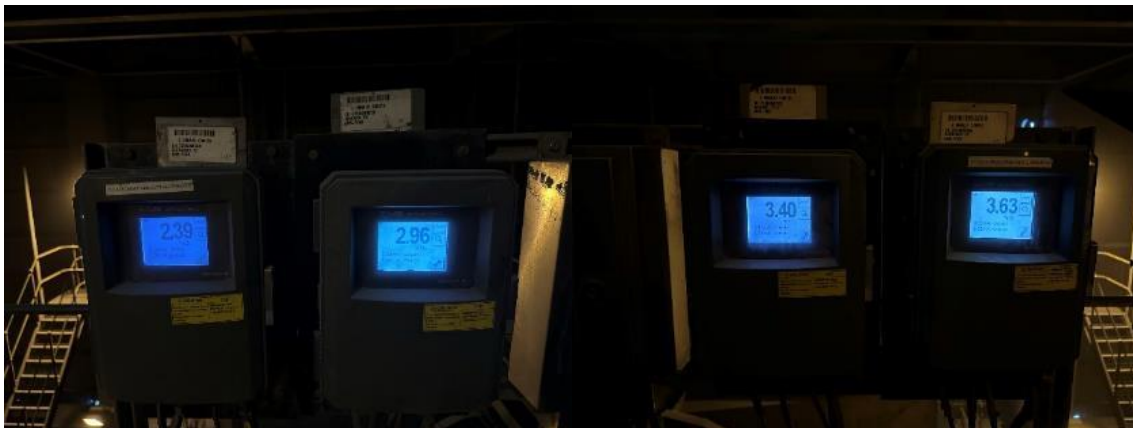
Figure 32: Measurement of oxygen in the flue gas at Arnot's Unit 3

During the Arnot site visit, there was also a discussion about reducing the O₂ limit with a view to generating more power from the boiler, potentially up to 20 MW on a unit generating 400 MW. Subsequent discussions with Eskom specialists were held and a summary of these discussions is listed in section 5.1.4.

The directive for operating plants at OEM O₂ limits came into effect after the explosion in the Duvha Unit 3 boiler in 2014, as a risk mitigation measure. This event resulted in the unit being taken out of service permanently. The most relevant recommendations from the investigation were to ensure operation without generating CO and to install sensors to confirm both O₂ and CO levels. Arnot has already started this process. Arnot is one of three power stations that has tangentially fired boilers that may benefit from reduced O₂ limits. Tests at Duvha in 2021 showed a very limited benefit for wall-fired boilers. Due to the seriousness of the risk, any change to the directive must go through an engineering change management process and be approved by “The Fossil Fuel Firing Regulations (FFFR)” committee.

During the site walk, poor insulation of components could be seen at various places. Two examples are illustrated in Figure 32. On the left side, an uninsulated opening to the combustion chamber can be seen. The glow radiating from inside the boiler, alone, demonstrates that high air ingress is taking place here. The second picture shows the drum, also with uninsulated components. Improper insulation of the components leads to:

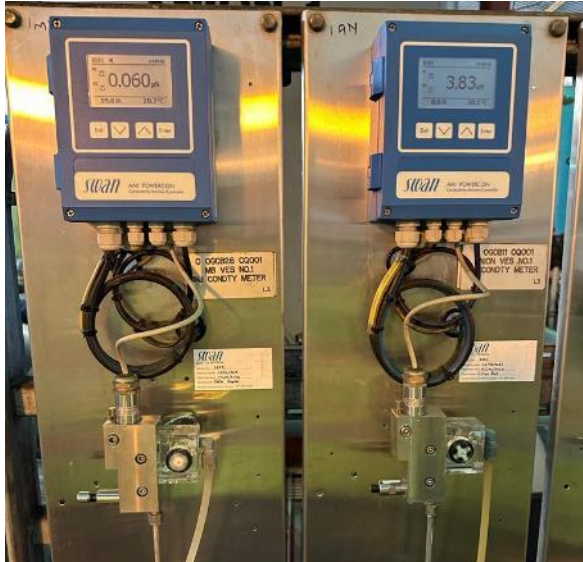
Figure 35: Instrumentation at Arnot's water treatment plant

New online measurement instruments have been installed at the plant (Figure 35). Also, the pre-treatment plant (flocculation) is currently being refurbished. It should also be mentioned that the offline sampling is carried out intensively by the site team. Water samples are taken and analysed for key performance indicators.

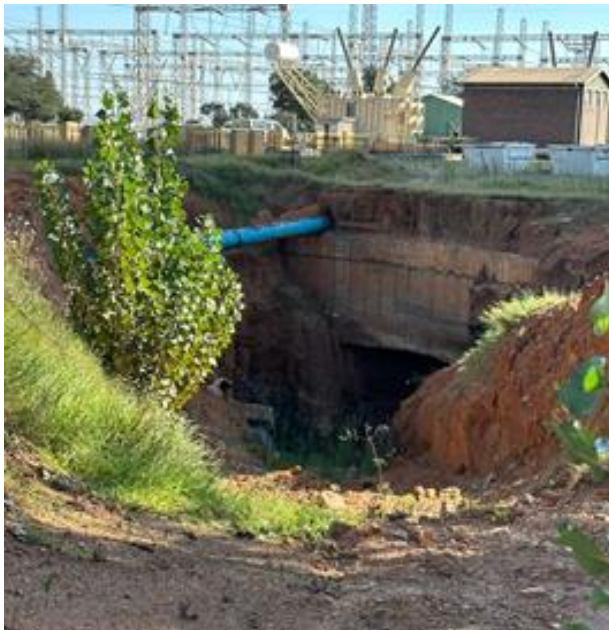
Figure 36: Sinkhole at the Arnot site

A consequence of this is the large sinkhole that occurred in Arnot. Due to a prolonged failure of a pump, the foundations and pipelines near the water treatment plant were exposed to the acid wastewater (due to un-neutralised sulphuric acid) and damaged severely and collapsed. To repair foundations, pipelines, and pumps, they must be excavated (more than 10 m depth).

Sinkhole: The ion exchangers in the water treatment plant at Arnot are regenerated with diluted sulphuric acid or caustic soda. The excess chemicals and the rinse water are discharged into the sump and subsequently dumped in the ash dams. Neutralisation of the waste water is not usually considered, both because of the lack of facilities for acid or caustic dosing and of neutralisation basins and also perhaps because of a lack of understanding about the possible consequences for pumps and concrete materials. A consequence of this disregard is the large sinkhole that occurred at Arnot. Due to a prolonged failure of a pump, the foundations and pipelines near the water treatment plant were exposed to acid wastewater (due to un-neutralised sulphuric acid) and were damaged severely and collapsed. To repair foundations, pipelines and pumps, they must be excavated (14 m depth).

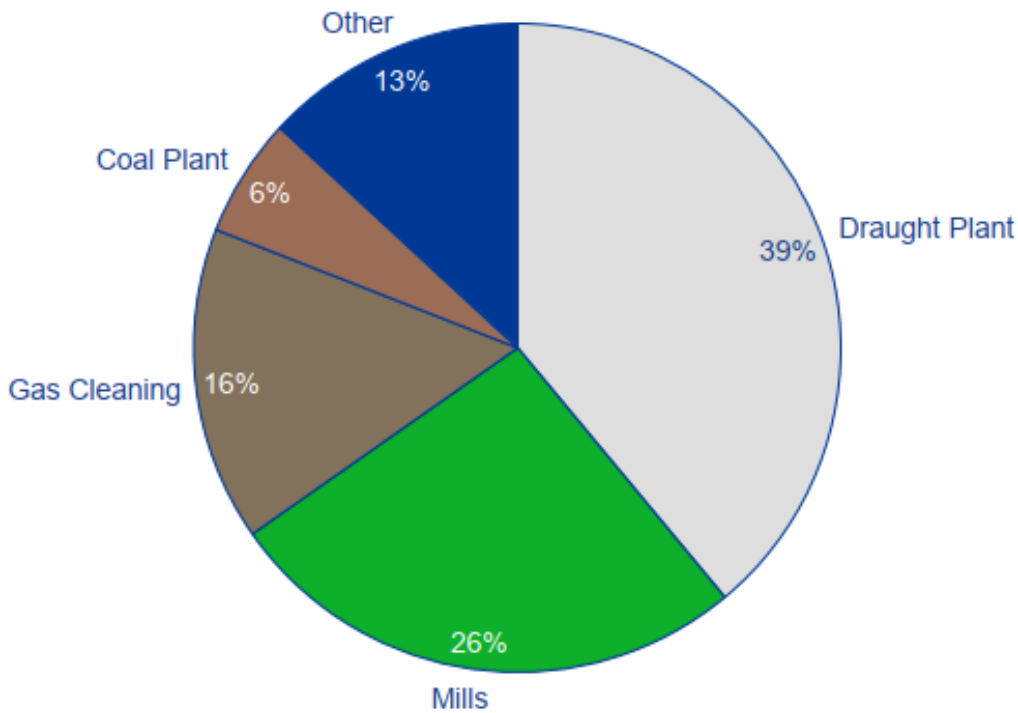
Figure 42: PLL contributors at Camden (FY200/2023 to March 2023)
Source: Eskom

The low EAF is mainly due to significant PLL. The main PLL sources between April 2022 and March 2023 are shown in Figure 42. As can be seen, many different components affected PLL – the main components being the draught plant (39%), the mills (26%), gas cleaning (16%), the coal plant (6%), the boiler, the condenser, the feed water plant and the pipework.

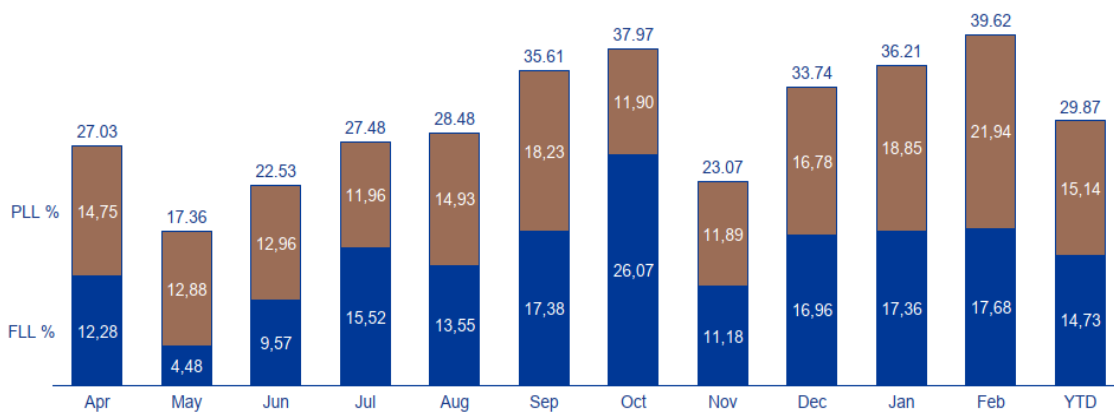
Figure 43: PLL and FLL distribution at Camden for FY2022/2023
Source: Eskom

The absolute numbers of PLL for the individual components and the total PLL have fluctuated over the course of the year. The values per month range from 11.89% up to 21.94%, thus marking a range of over 10%. The average PLL for FY2023 so far is 15.14% and, as such, exceeds even the full load loss (FLL) for the same period, which is 14.73% (see Figure 43).

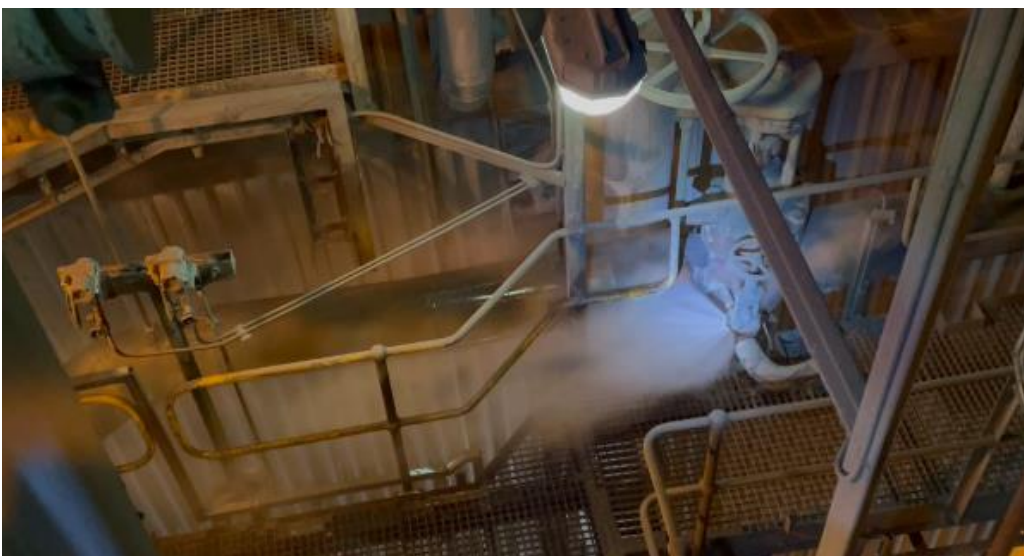
Figure 45: Valve leakages in Camden's boiler house

Steam leakages: In the boiler house, numerous steam leakages were found in various positions, both on valves and on the piping itself (see Figure 45).

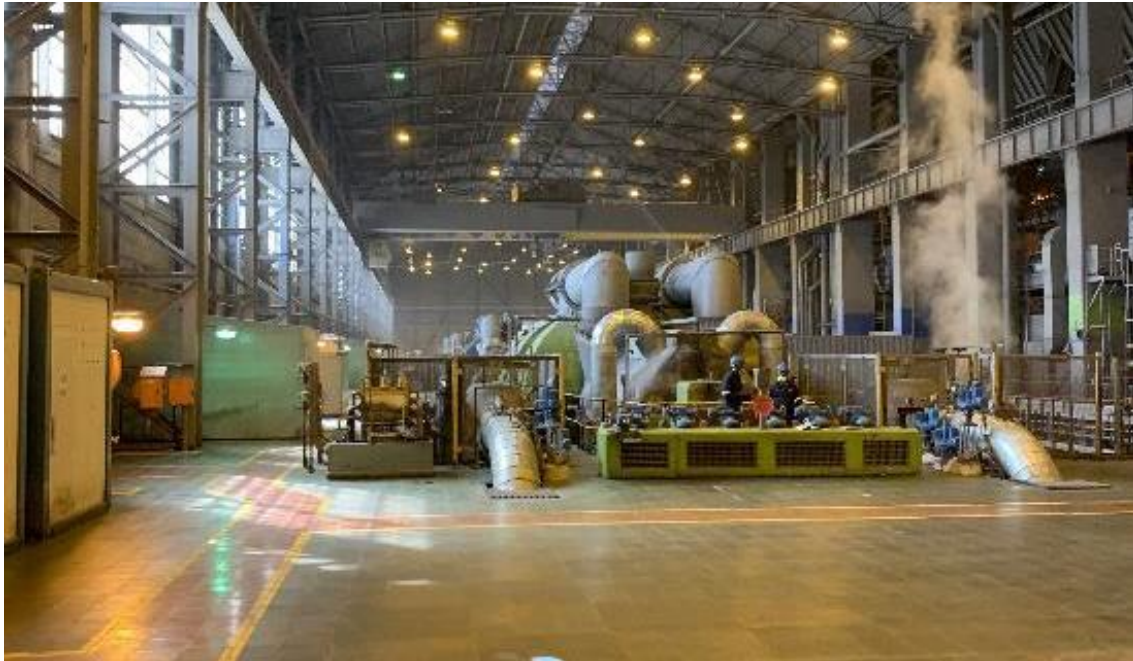
Figure 49: Turbine hall at Camden power plant

Turbine: Firstly, the turbine hall was reasonably clean, as the housekeeping was conducted well (see Figure 49). The turbines were covered only with a thin layer of dust. Several leakages were detected within the turbine area. Only a few of these leakages were part of the interconnection piping and HP heaters.

Units 4, 6, 7 and 8 have already exceeded the end of their inspection interval and need a general overhaul. Their overhaul has been delayed because of the planned shutdown and decommissioning of the power plant and due to high grid demand. Due to the exceptional circumstances - unreliable and insufficient power supply - a recommendation would be to check

whether it is possible to extend the lifetime of the plant. If this is an option, the above-named units should be overhauled as soon as possible.

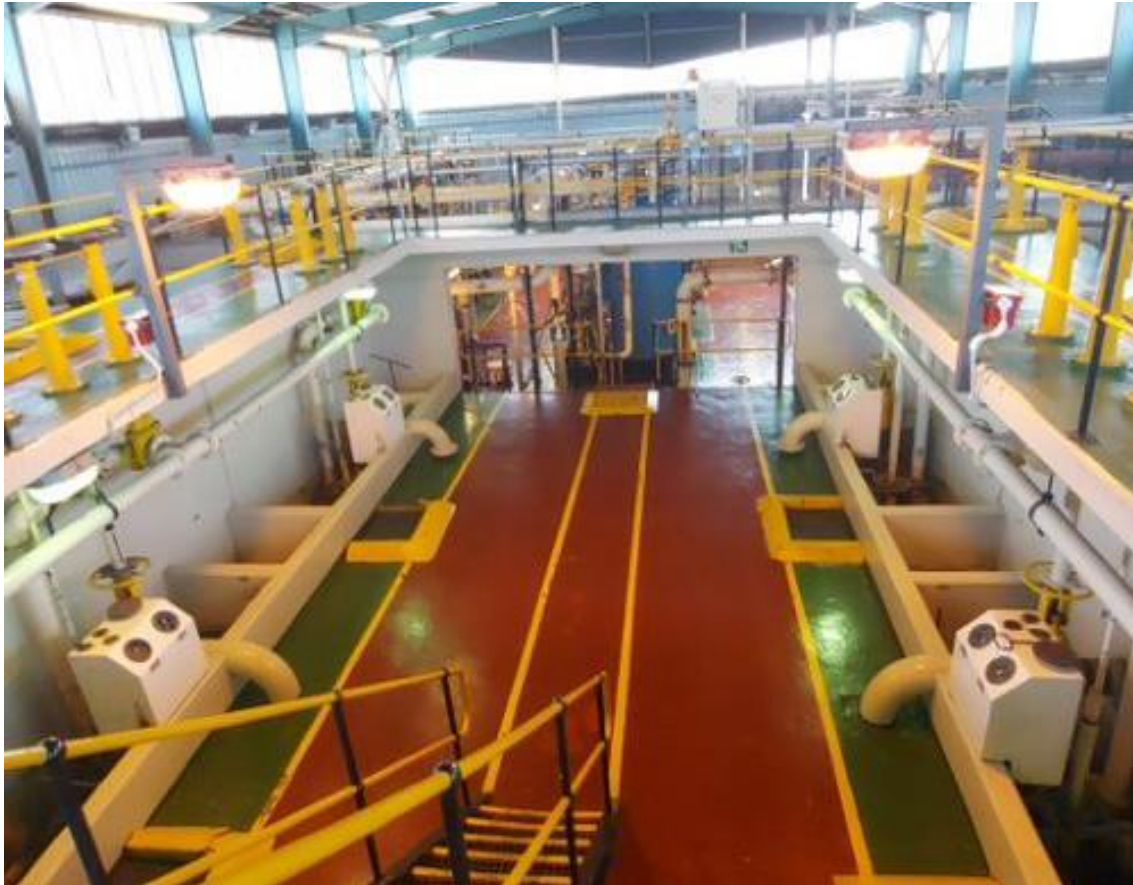
Figure 54: Water treatment plant at Camden power plant

Make-up water plant: The central make-up water plant was visited during the site walk. The building of the water treatment plant was clean and, overall, in order (see Figure 54). The capacity of the make-up water plant is sufficient to cover the consumption needs of the site. The quality of the water is as it should be in most cases, with only minor increases in SO_4 amounts.

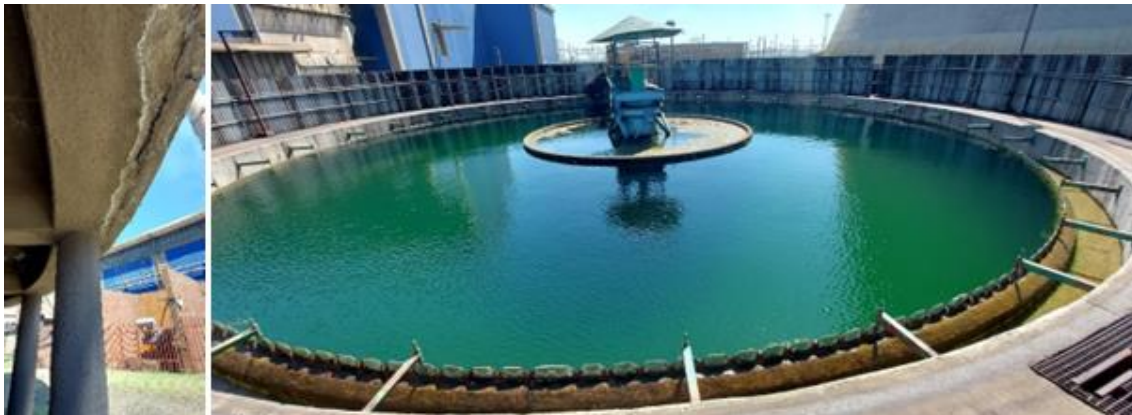
Figure 55: One of the clarifiers (right) and signs of wear and tear (left) at Camden

Clarifiers: The clarifiers civil structures show signs of wear (see Figure 55). Refurbishment of the parts might be advisable.

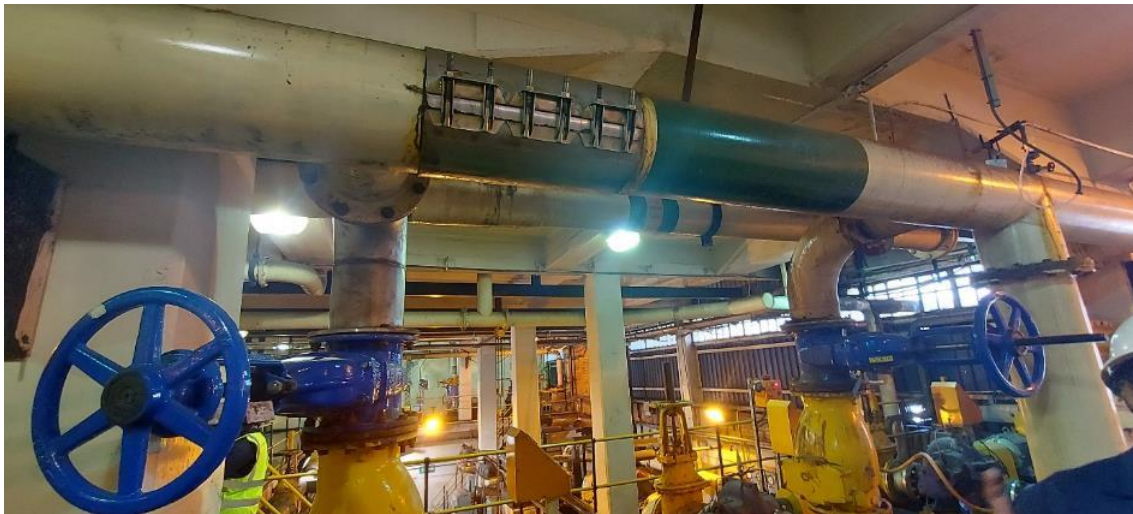
Figure 56: Critical service water line with quick fix installed at Camden power plant

Piping: The piping of the water make-up plant is in a moderate condition. Some of the pipes and junctions have already been exchanged. However, there are critical service waterlines that have only received a quick fix but require urgent extensive repairs in order to keep the plant running (see Figure 56).

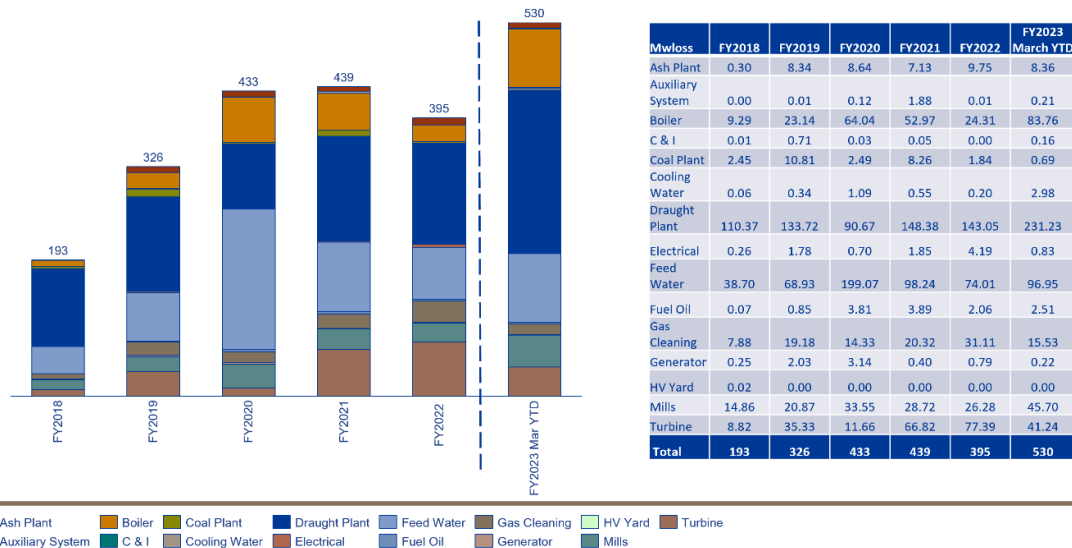
Figure 58: PLL contributors at Duvha power plant (FY2017/2018–FY2022/2023)¹⁶

The absolute numbers of the PLL for the individual components has fluctuated over the years, showing a tendency to increase from FY2017/2018 to FY2020/2021 and a slight improvement in FY2021/2022. At the beginning of FY2022/2023, a significant increase of the PLL can again be identified. The reason for this can be found in the dramatic increase of losses at the draught plant.

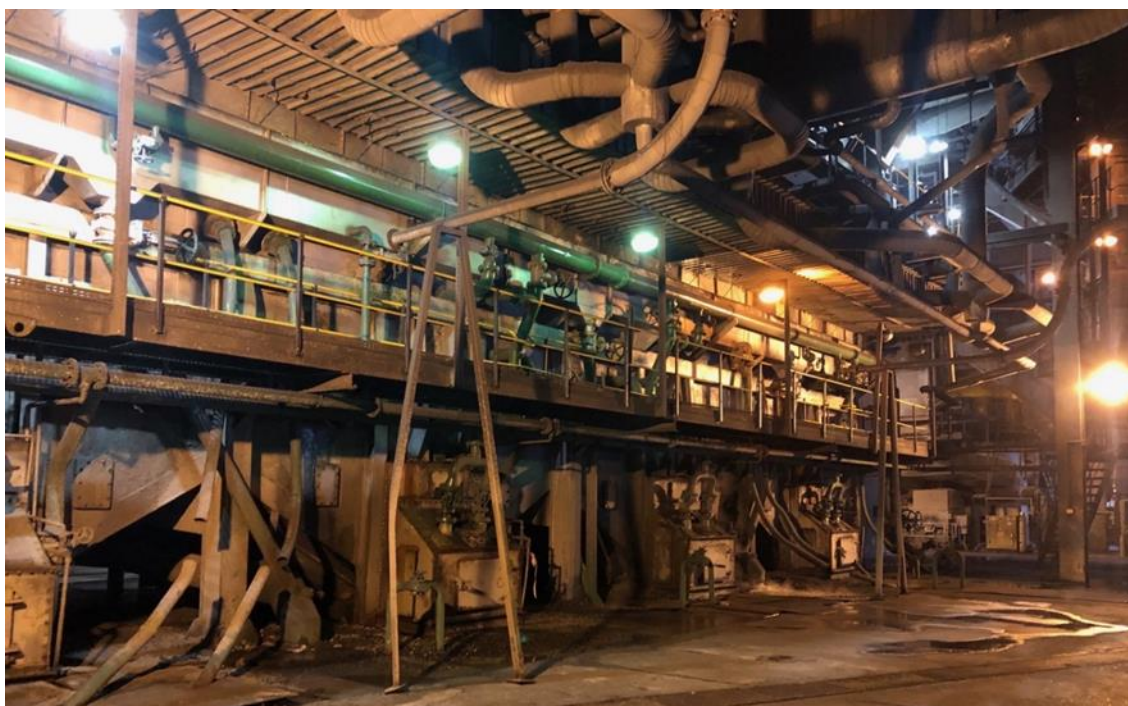
Figure 59: Duvha boiler level 0 m

During the visit, the team walked through the boiler house. The **housekeeping** was acceptable (see Figure 59). Levels of dust, ash or coal were not high. Furthermore, no safety-related issues were noted.

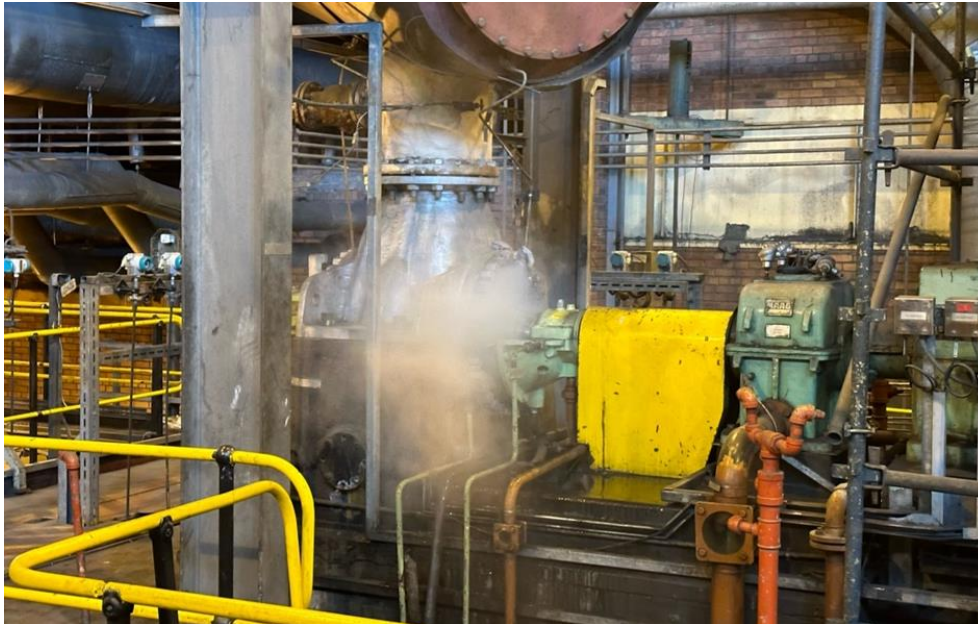
Figure 62: Leaking pump in Duvha's boiler house

Turbine: The turbine hall was reasonably clean, as the housekeeping was conducted well. However, the noise level was very high. The reason for this could not be directly identified. Leakage was visible on Unit 2's feed water booster pump. Unit 1's turbine had a leakage directly at the turbine. This leakage will increase further and represents a health and safety risk. Therefore, it needs to be repaired during the next outage.

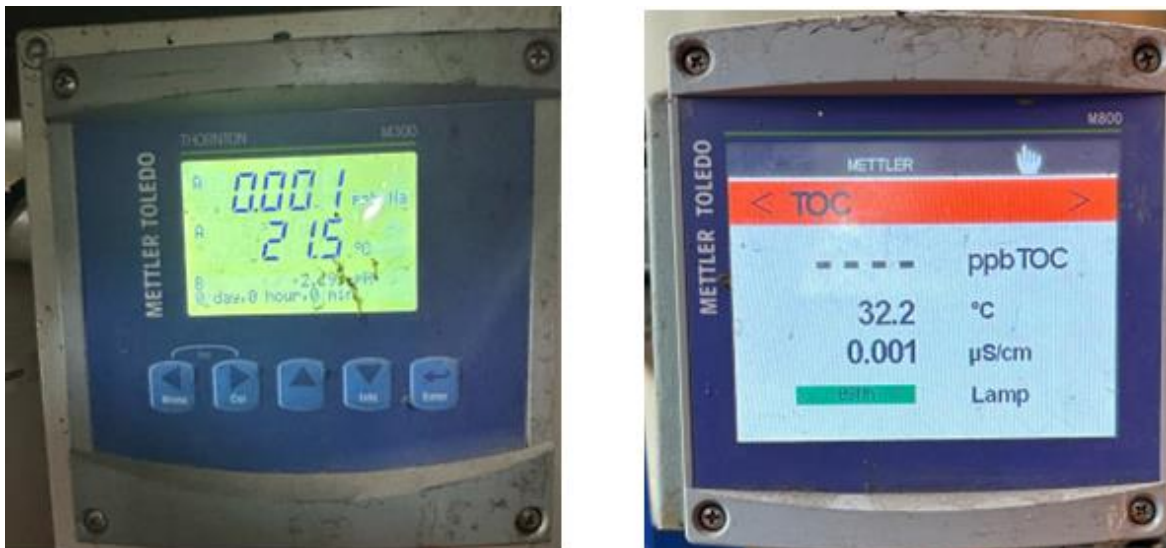
Figure 63: Measurements at the Duvha water treatment plant

However, the water make-up plant is not in good condition. Nearly all online measurement instruments installed in the plant are not working (Figure 63). These photos of the sodium / TOC measurements display implausible values.

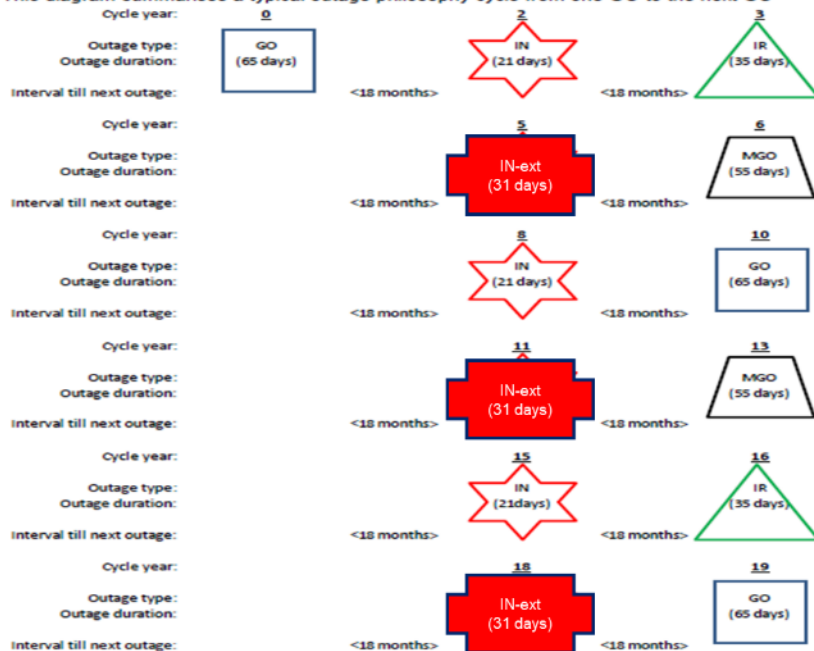
Figure 65: Outage sequence in Duvha

Extend the 37 500 hour LP Turbine inspection to a 31-day outer hood off inspection

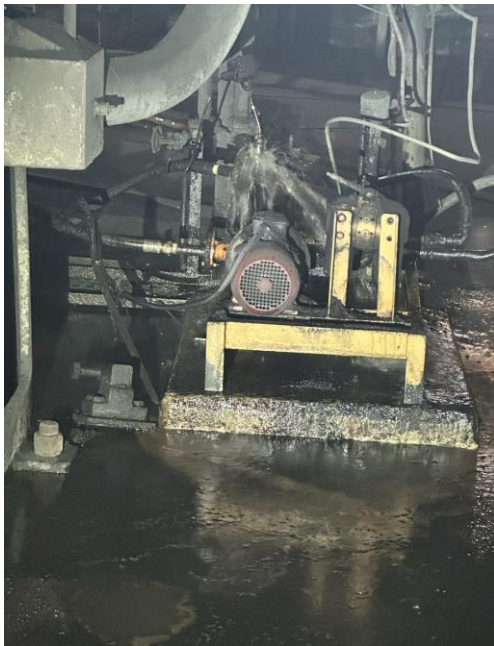
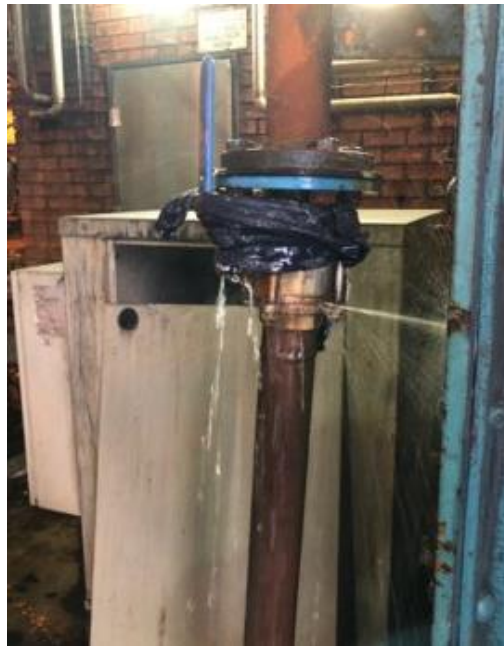
Figure 68: Water leakages in Grootvlei's dusty boiler house

In addition to this, many **water and steam leakages** were found – especially at ground zero. In some parts of the boiler house (at ground zero), the whole floor was completely flooded by water.

Apparently, water consumption at the plant is relatively high. One reason for this is the excessive number of leaks in the water steam cycle. Safety valves were visibly leaking badly. These also need to be fixed right away, to avoid any accidents. The number of leaky valves and the related water loss have reached a level that results in capacity shortages of make-up water.

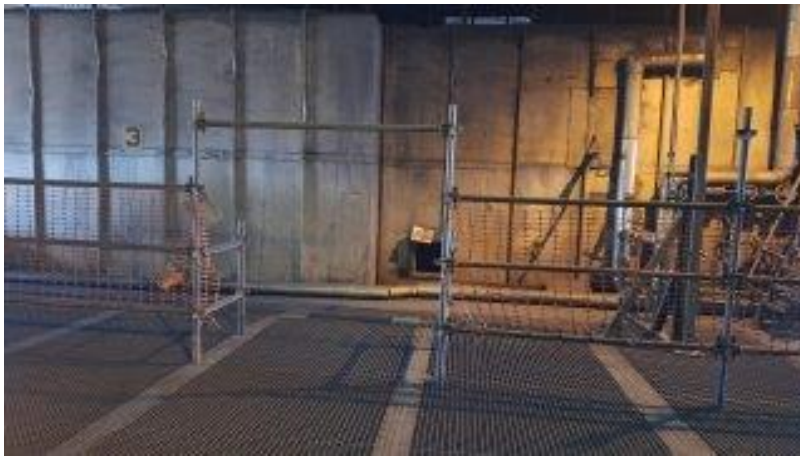
Figure 70: Fenced working area at Grootvlei boiler house

During our site walks, it was noted that areas in which maintenance work was being conducted were properly fenced and signed.

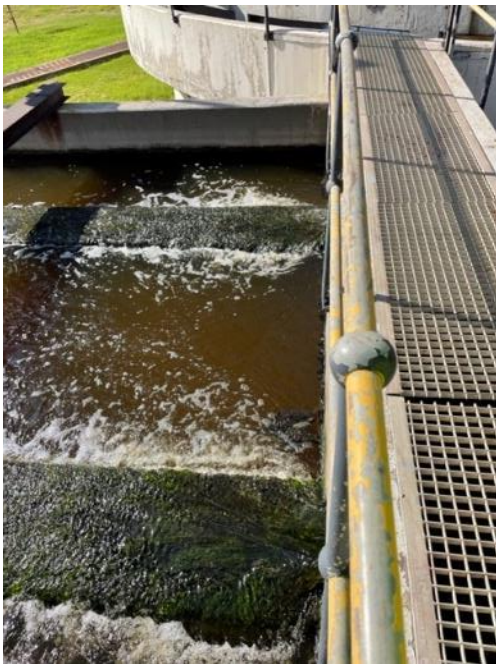
Figure 72: Pre-treatment of Grootvlei's cooling water

However, not all basins in the pre-treatment for turbidity reduction have been sufficiently cleaned yet. This will be done during the next outage. As can be seen in the photo, the algae in the tank are causing the water to be loaded with total organic carbon.

In summary: The treatment of cooling water needs special focus in order to avoid clogging and leakage formation in the condenser tubes.

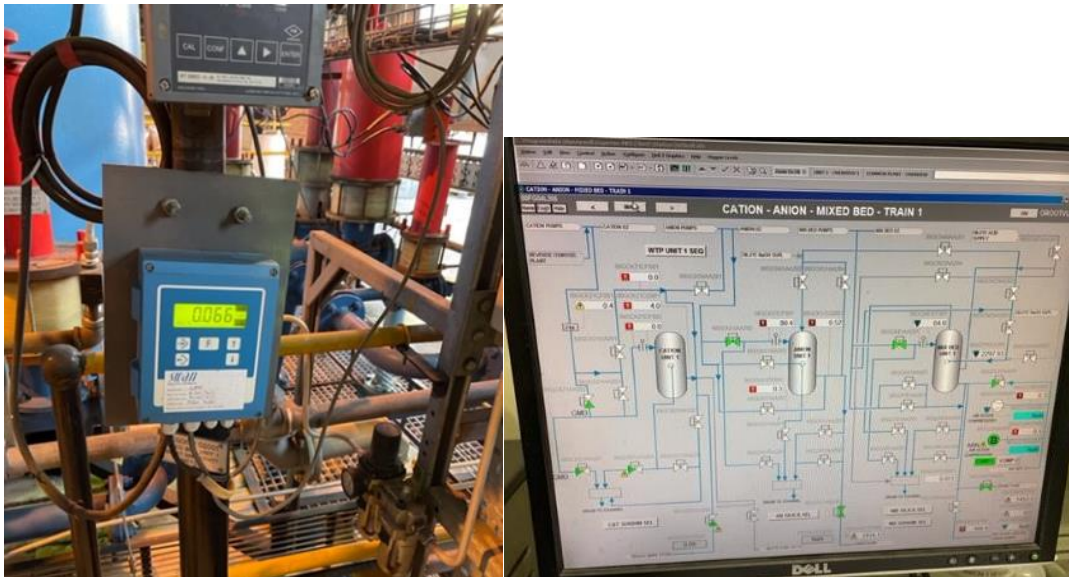
Figure 75: Measuring and monitoring instruments at Grootvlei's water treatment plant

At times, the capacity of the make-up water plant is not sufficient to meet the site's consumption with water of adequate quality. This is due to high losses caused by steam and water leakages at the plant and in the cooling system.

The conductivity data (CACE) provided for feedwater, boiler water and steam indicates that the quality is not always sufficient, possibly caused by condenser tube leaks. This can lead to damage, such as BTL.

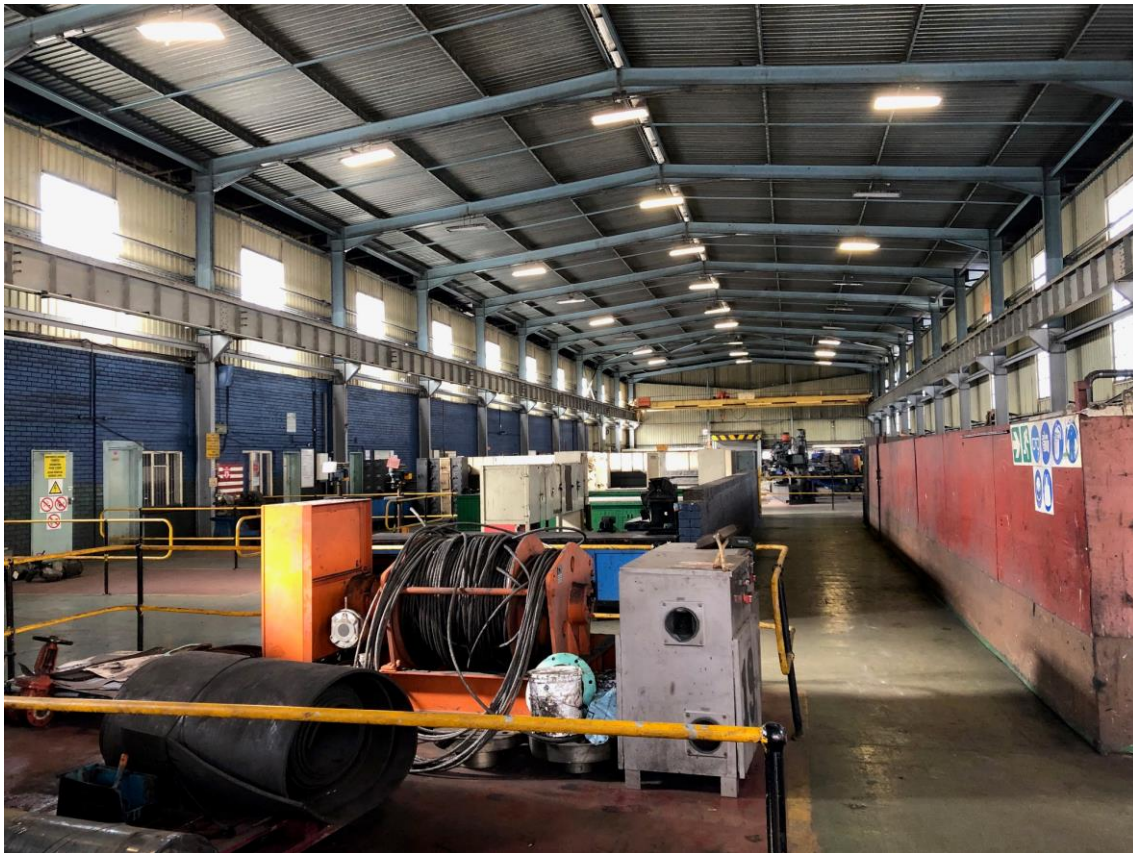
Figure 77: Maintenance workshop at Grootvlei

There is a **maintenance workshop** which is used by contractors, as the maintenance is fully outsourced at this station. It is spacious and well-equipped, although most machines are quite old. However, the facility should be used to as much as possible to fix the various defects at the plants.

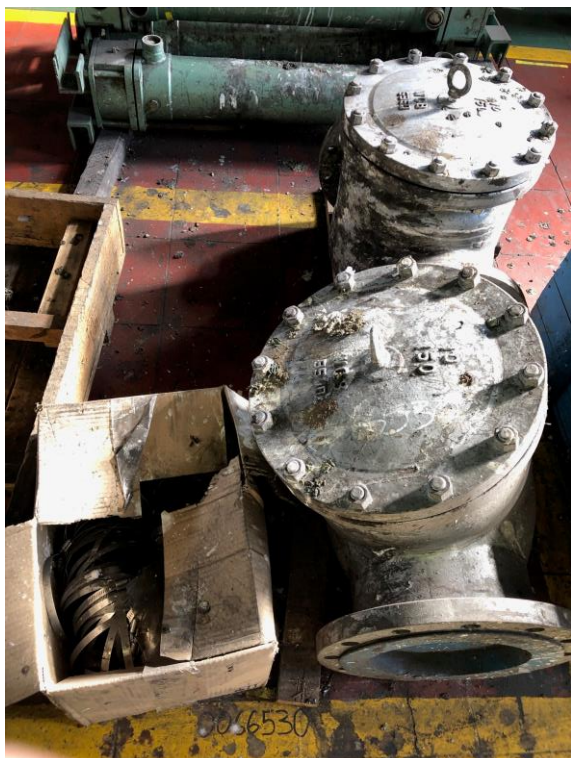
Figure 78: Dirty spare parts at Grootvlei

The spare-parts store was in poor condition – especially, with regards to the conditions in which components are stored. Many of them were covered in dirt and pigeon droppings. Also, high quality components, such as shafts with sealing surfaces, were partly corroded. In their current condition, these parts would not be fit to use. Hence, the vgbe team recommends improving the situation by reducing the number of birds (pigeons) in the store and covering the components. The stored components should also be checked to see whether they can still be used or what measures have to be taken to make sure that they can be used if they are urgently needed.

The storage conditions in the spare-parts warehouse have to be improved considerably. There is a serious problem with pigeon droppings, and measures to prevent birds entering the warehouse need to be urgently implemented. In addition, there needs to be proper dirt and dust protection (e.g. protective cover) for components and equipment parts.

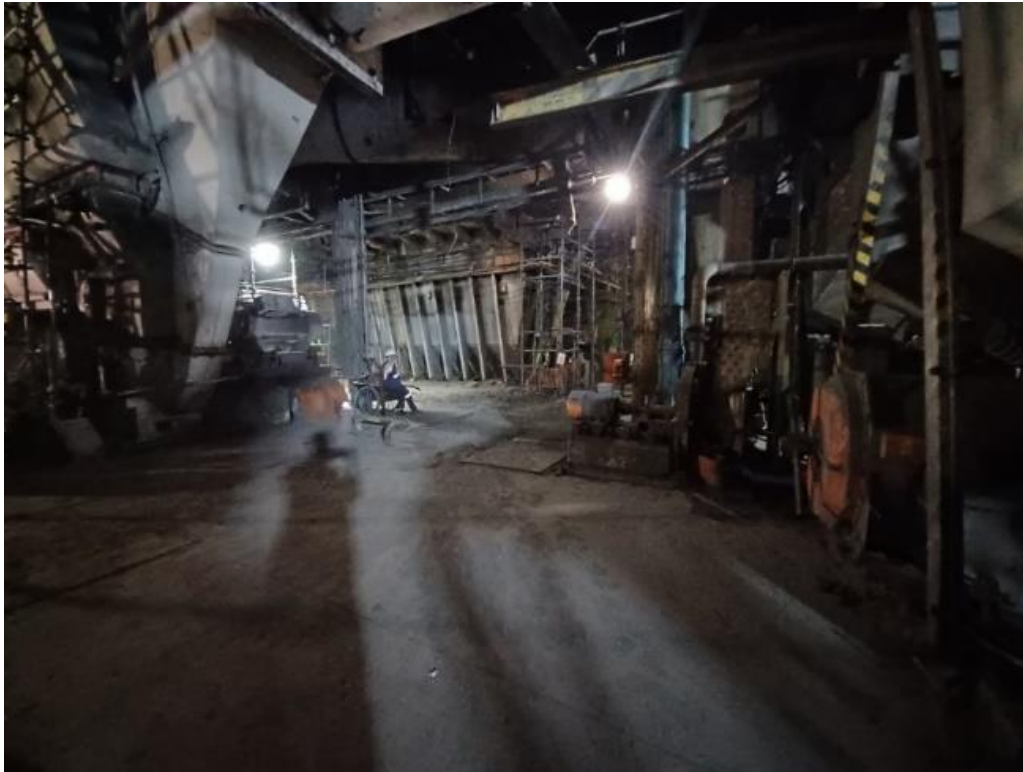
Figure 85: Hendrina boiler at 0 m level

During the visit, the team walked through the boiler house. In general, the housekeeping was acceptable (see Figure 59). Dust levels were not extreme and there were no visible leak-ages. No safety-related issues could be observed.

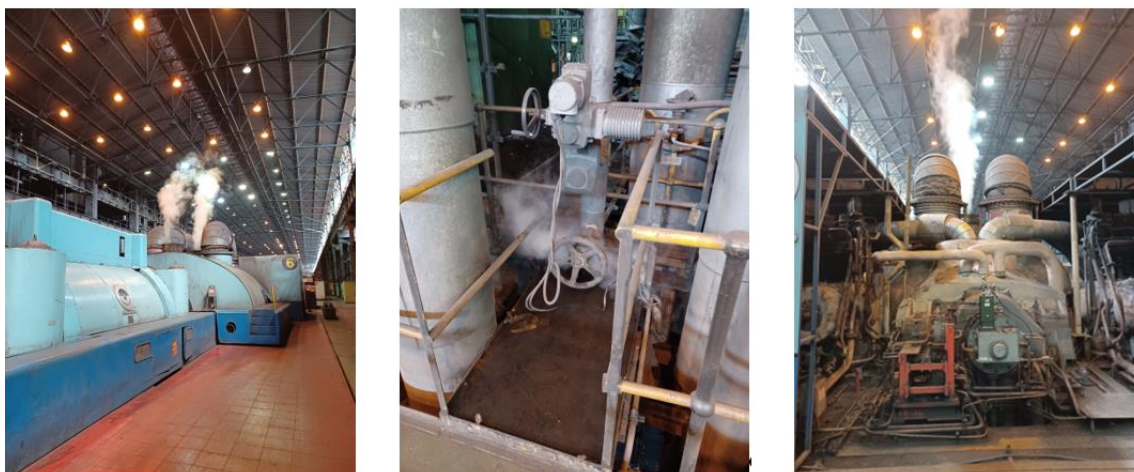
Figure 88: Turbine hall at Hendrina

Turbines: Kraftwerk Union impulse-type HP and reaction-type double flow LP, double-casing condensing turbines have been installed. Approximately half of the turbine hall is reasonably clean. Steam leakages were visible on the valves/sealings in several places.

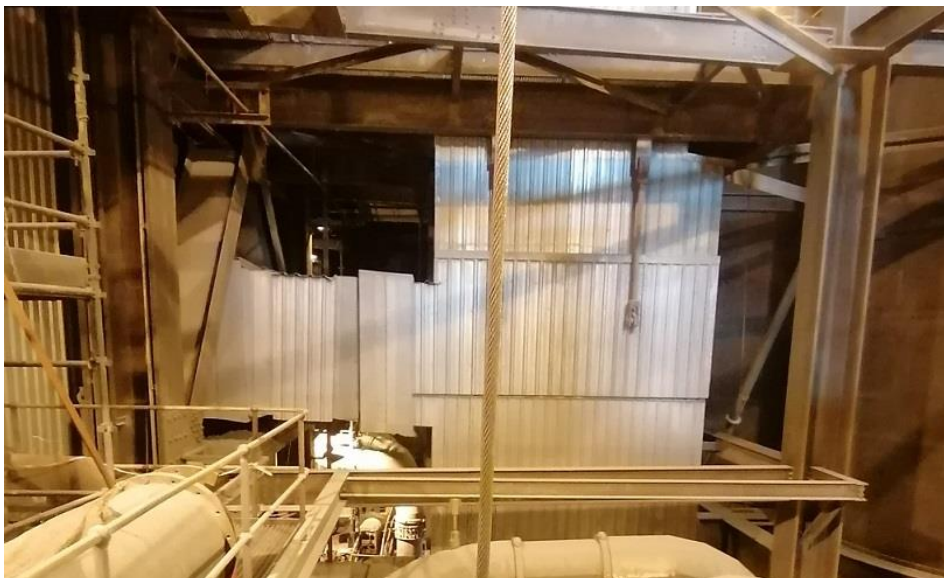
Figure 96: Kendal Unit 4 – same PAH duct not covered in ash and dust (April 2023)

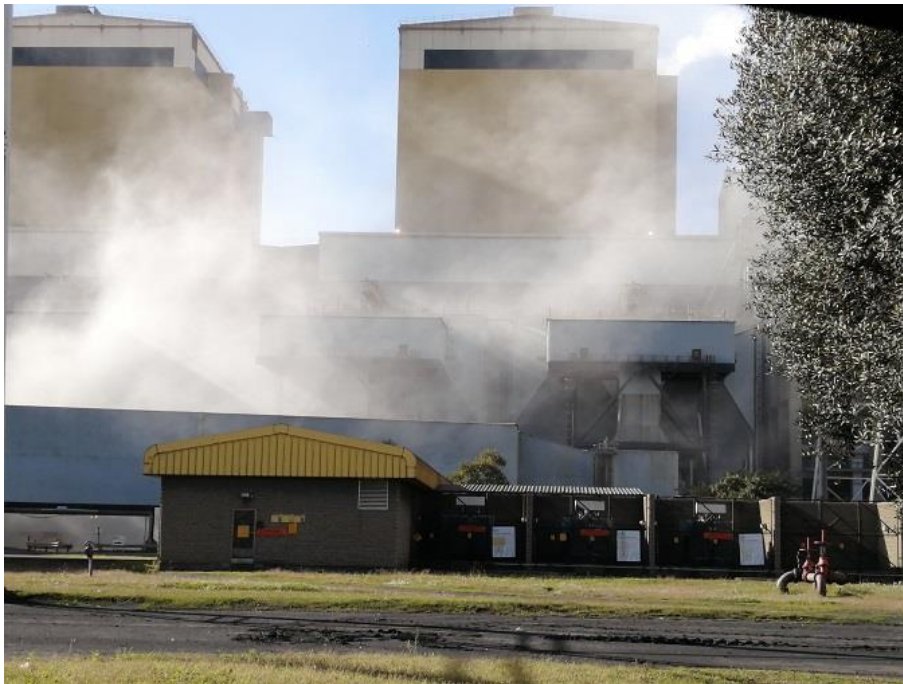
Figure 98: Kendal station covered in a dust cloud: May 2022

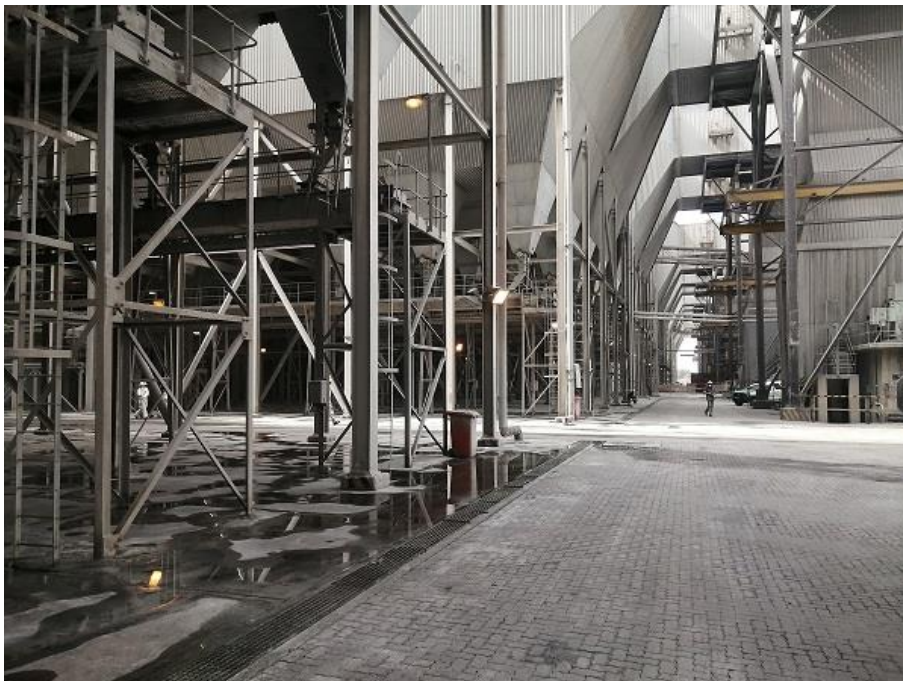
Figure 99: Kendal's ESP clean and dust cloud is completely gone: April 2023

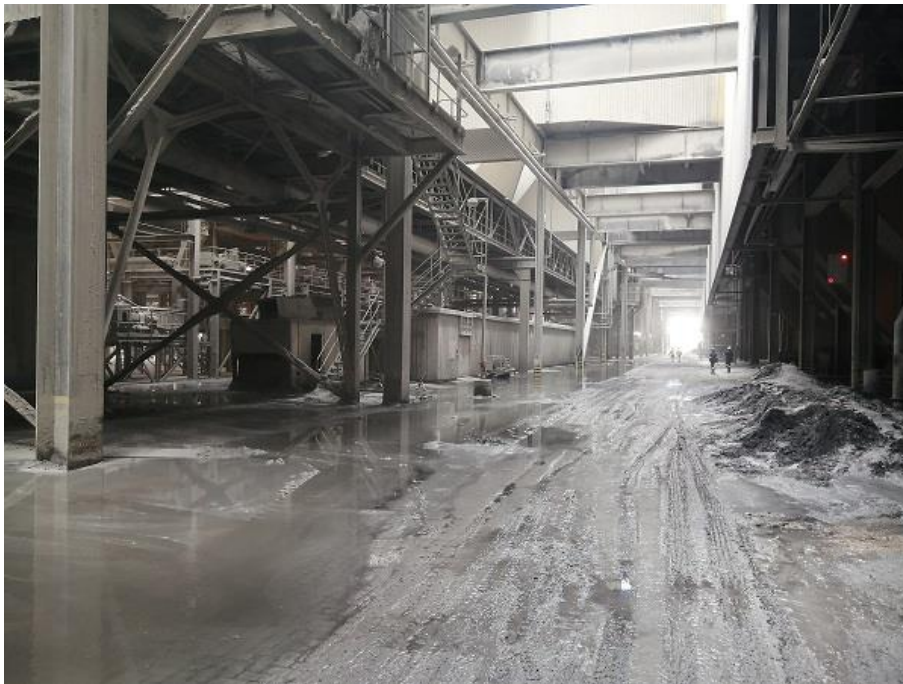
Figure 100: Ash in Kendal's boiler house

It has not been completely addressed but certainly much better than 12 months ago: April 2023
